Manhole Inspection Summary

Manhole # S29E__035MH

Location Address: **220 N. Pine St**

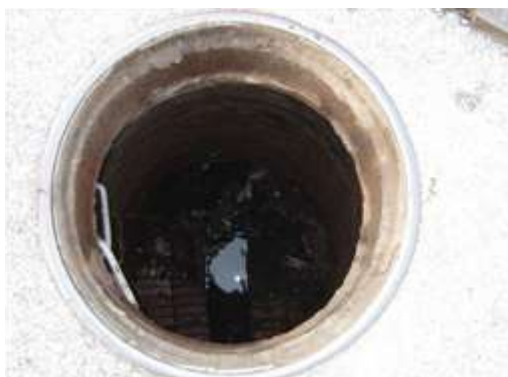
Defect 2

Corroded steps

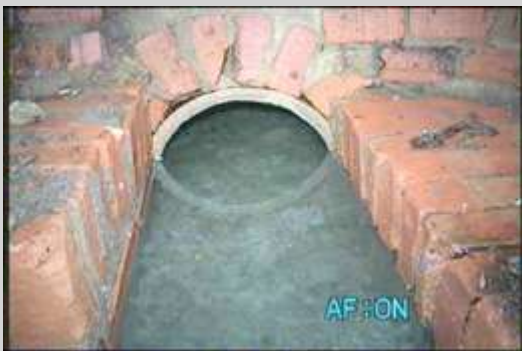
6 O'Clock Inflow

10 in. Circular Gravity Sewer
Pipe In @ 6 O'Clock

Pipe Height: **10.8** (in.) Rod and Bar (Angled)
Pipe Material: **Clay** ☐ Pipe Lined
Invert Depth: **9.38** (ft.) Flow Characteristics: **Slow**
Deposits: ☒ **None** ☐ Mud ☐ Sludge ☐ Debris ☐ Grease
Silt Depth: **0** (in.) Deposits Extent:
Infiltration: **None** Pipe Seal Cond: **Sound**
